Stationary discharge measurement in Saxony at the Zschopau River

2 OTT SLD & LogoSens 2

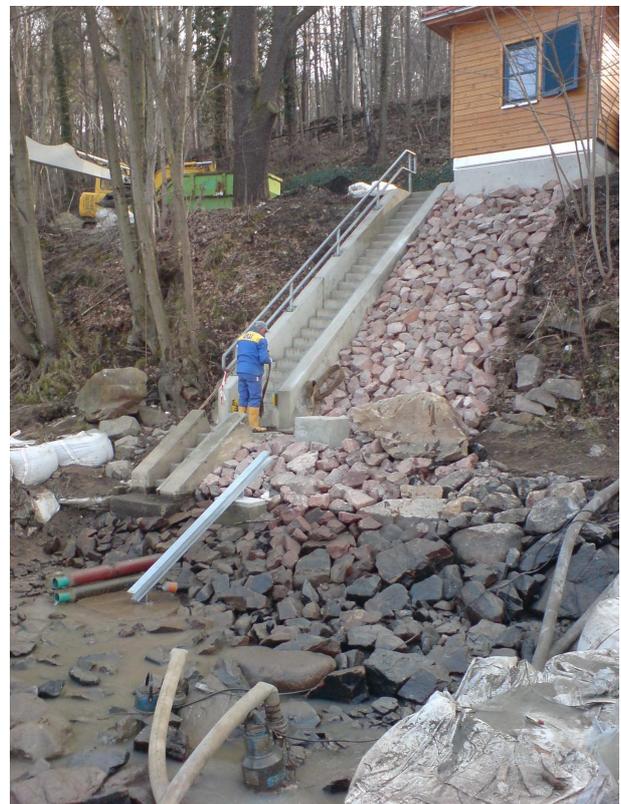
The gauging station under reconstruction. The carriers for the two SLDs can be clearly seen in the drained channel

The sensor of the lower measuring path was installed vertically adjustable on a double-T-carrier, the upper sensor was fixed to a concrete foundation on the slope.

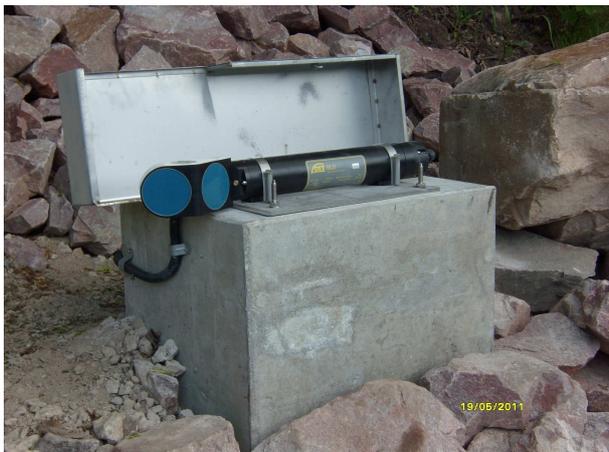
Mounted sensor of the upper measuring path with lockable protection cover.

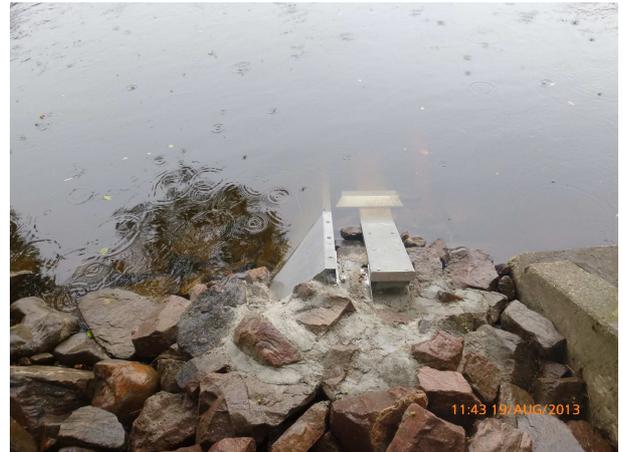
Rebuilt carrier of the lower measurement path with deflector

During the high water in the Zschopau River in June 2013, the carrier of the lower sensor was damaged by flotsam. The sensor could not provide reliable data anymore. At the moment the discharge values are being reconstructed on the basis of the measurements of the upper sensor.

Die Befestigung beider Sensoren wurde noch einmal professionell durch einen externen Dienstleister (HydroTec Berlin GmbH) überarbeitet, so dass der Betreiber bei künftigen Hochwässern wieder auf zuverlässige Daten zurückgreifen kann
